To: Advisory Board of Directors
From: James Perry, Park Services Manager
Date: September 16, 2021
Subject: Facilities Assessment Report – Deferred Maintenance

FACILITIES ASSESSMENT REPORT

LA SIERRA COMMUNITY CENTER

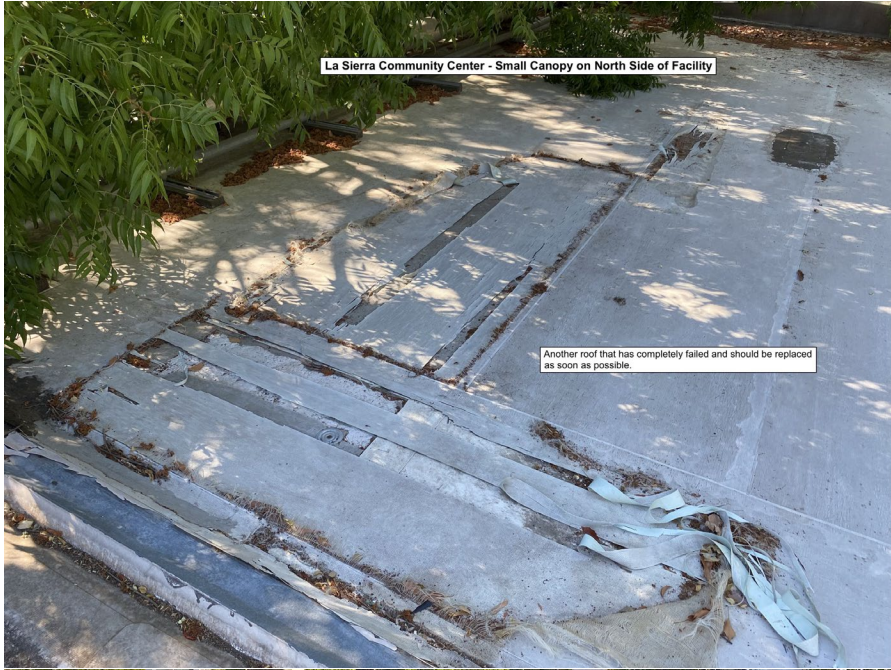
La Sierra Community Center - Small Canopy on North Side of Facility

Another roof that has completely failed and should be replaced as soon as possible.

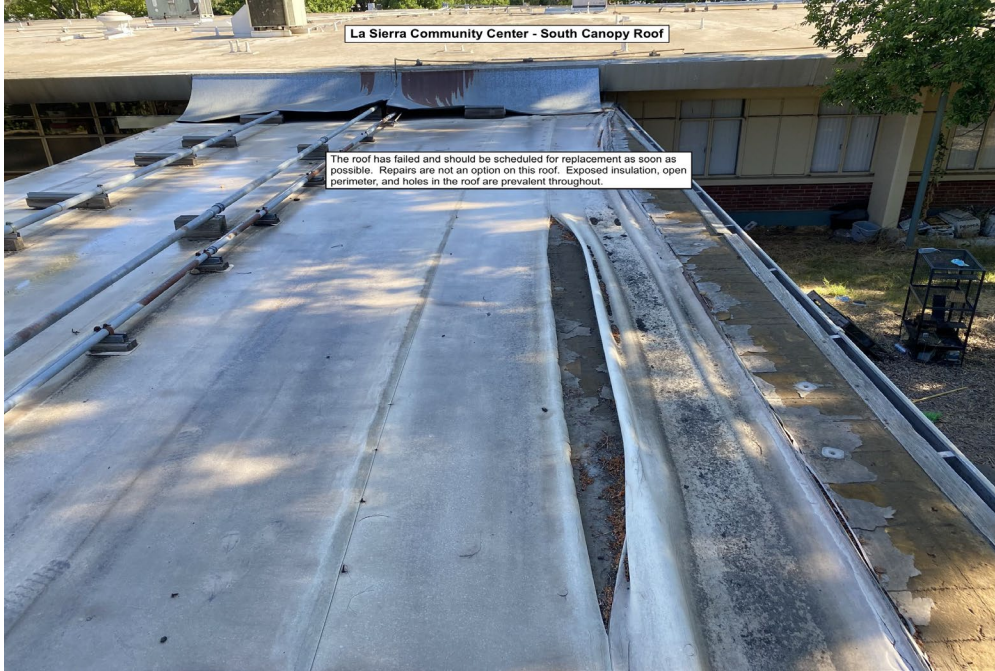
La Sierra Community Center - South Canopy Roof

The roof has failed and should be scheduled for replacement as soon as possible. Repairs are not an option on this roof. Exposed insulation, open perimeter, and holes in the roof are prevalent throughout.

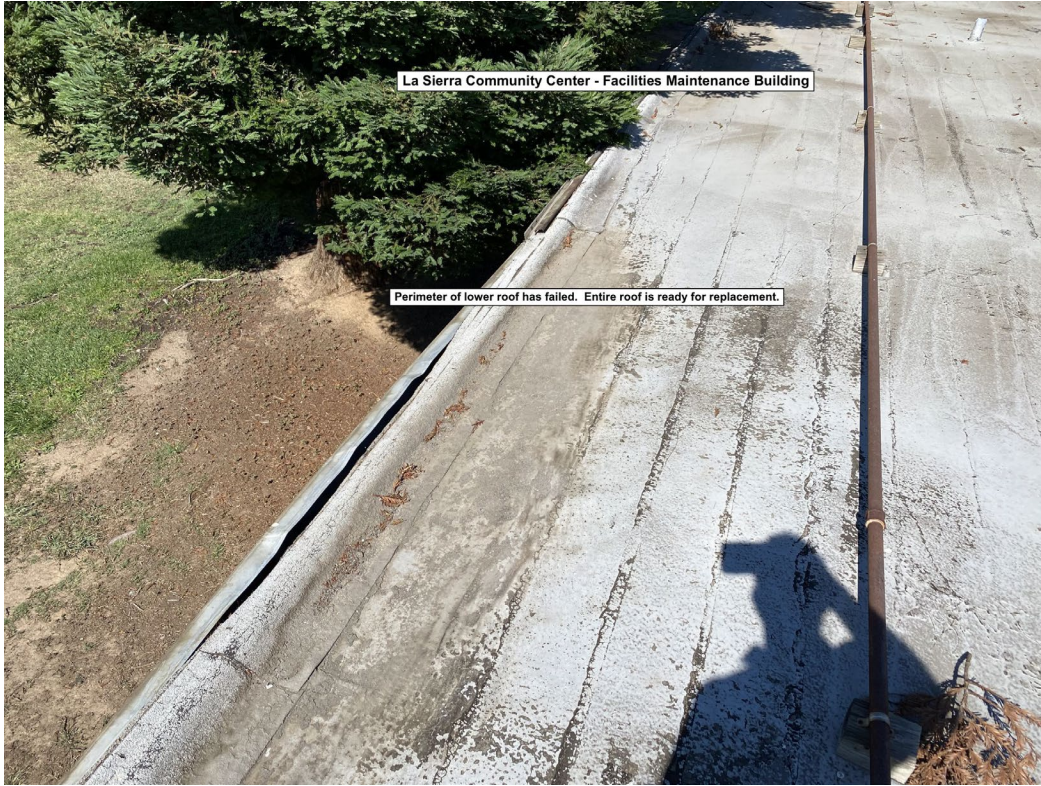
La Sierra Community Center - Facilities Maintenance Building

Perimeter of lower roof has failed. Entire roof is ready for replacement.

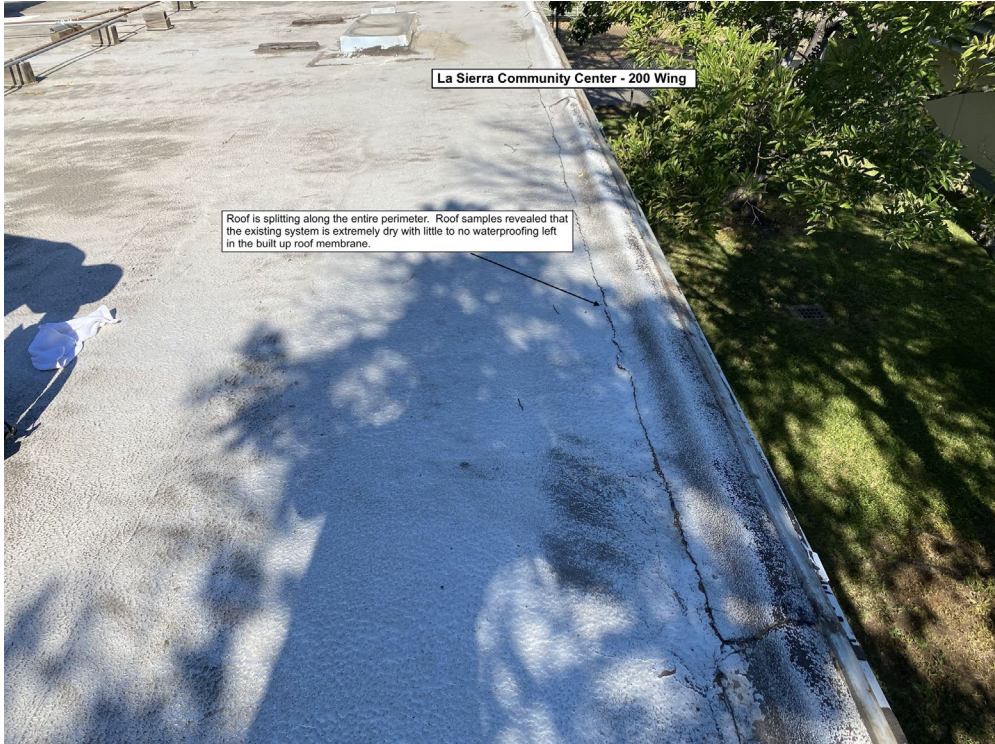
La Sierra Community Center - 200 Wing

Roof is splitting along the entire perimeter. Roof samples revealed that the existing system is extremely dry with little to no waterproofing left in the built up roof membrane.

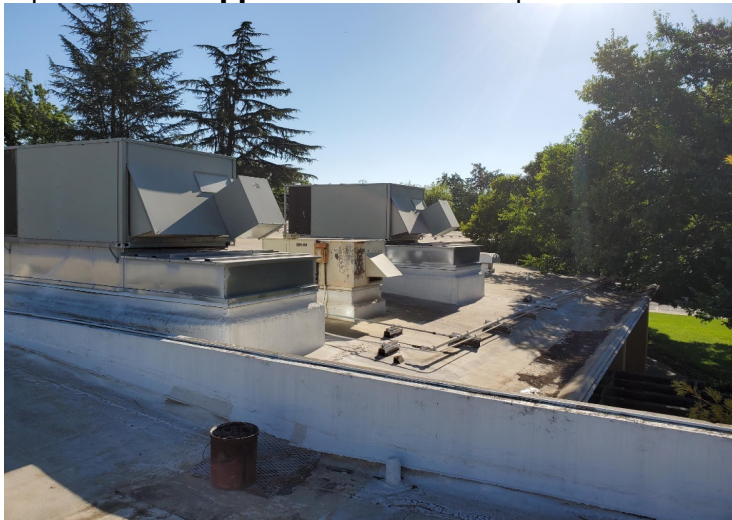
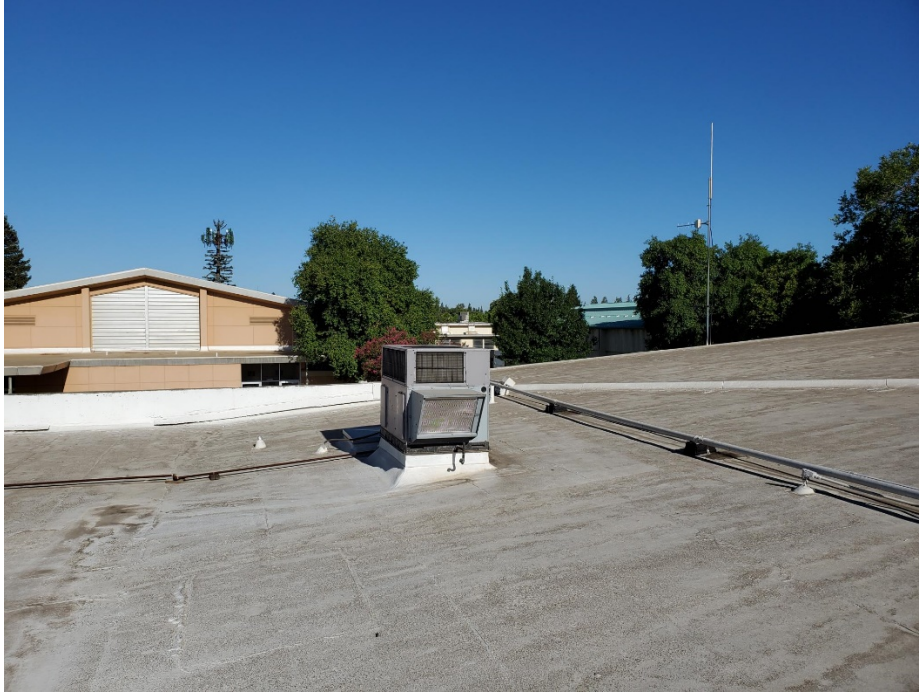
Once again, the roofs were walked upon as the HVAC units for this campus were reviewed. While units did range from 11 to 34 years in age, most at this site are overdue for replacement. **Appendix B** has a complete outline of number of units and associated scope

that would need to be addressed on each wing and building at this campus.

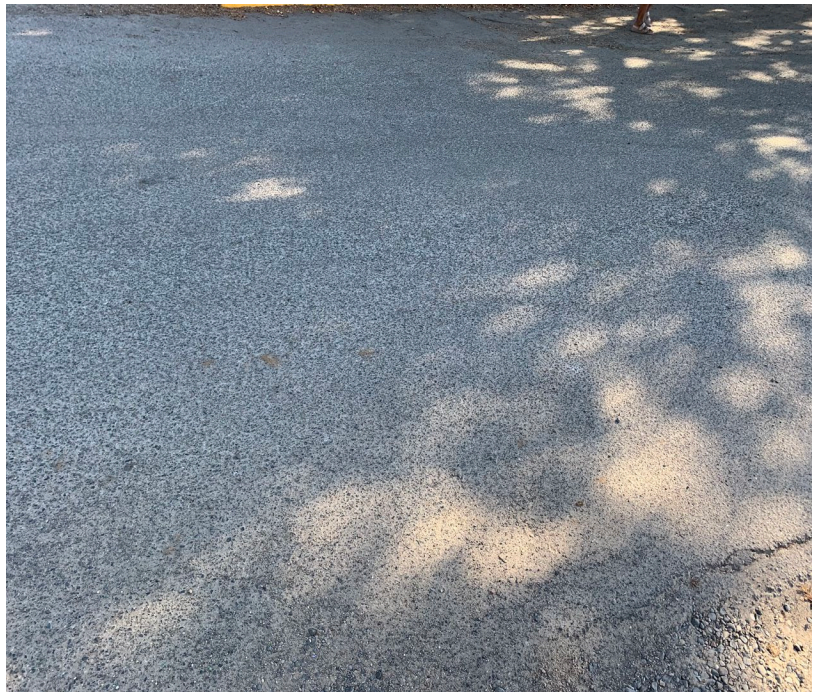
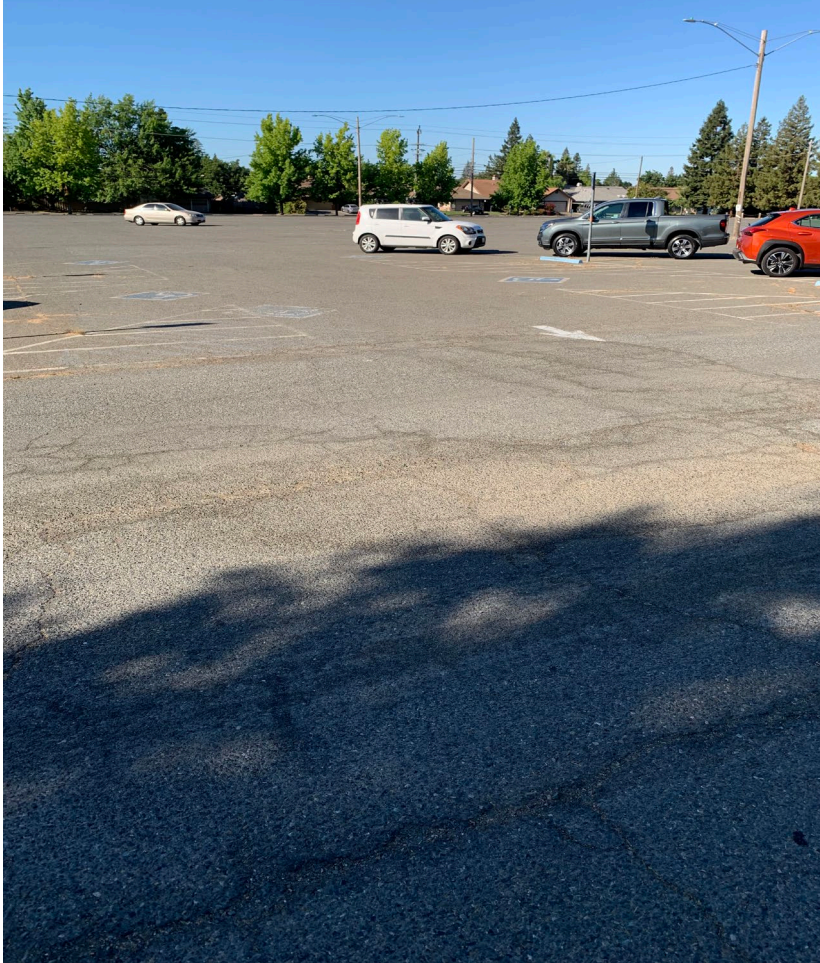
Much of these lots are presenting with severe cracking, to which filling, and slurry coating will not hold.

The general recommendation for these paved areas is to grind down the top 3" (approximately) and apply a new topcoat of asphalt. However, it has been noted that in the past during repairs the current asphalt was not installed with base. With that information, it is recommended that an engineering firm be engaged to perform a coring to fully determine the needs of the site. In order to budget appropriately, a full tear out and replace is quoted in site costs.

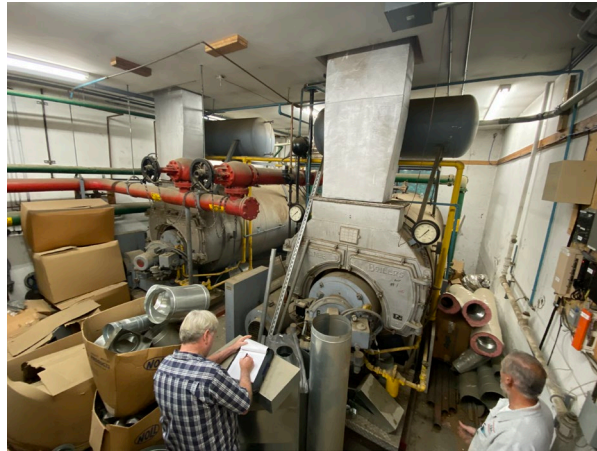
Boiler Room at La Sierra

La Sierra Campus holds two separate boiler rooms that were once used to heat the entire campus. Many of the roofing areas still have abandoned piping that can be removed as roofing is replaced. However, these boiler rooms and machines contain asbestos that has been well documented. Because of the significant size of the equipment contained in these rooms, the boilers must be broken down in place and then taken out and disposed of in individual pieces. This is what has made this project difficult to execute and fund.

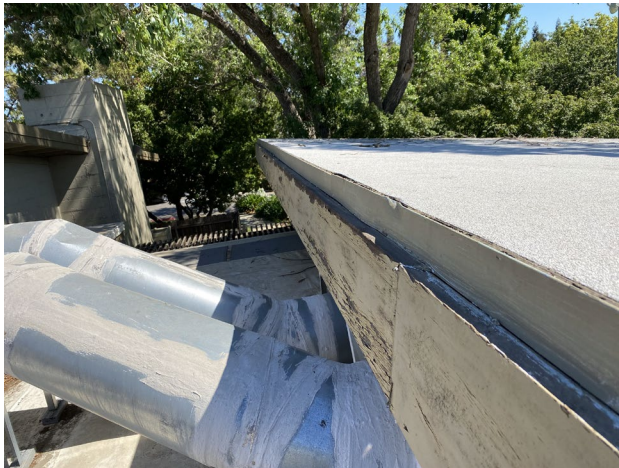
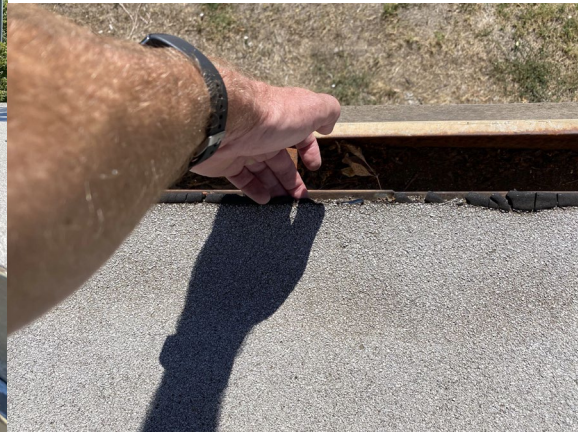
However, the roofing above a portion of the District Office, on the East Side looks in fairly good shape at first glance but in fact is slipping from the top of the roof slope. This presents itself as overlapping layers and there is an overhang of roofing materials beginning to show along the edge.

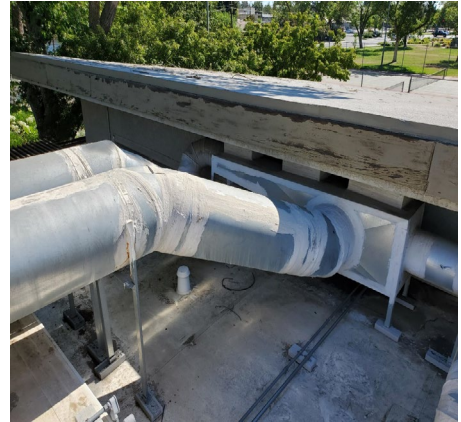
The units at this site are generally not only at the end of their useful life, but much of the installation and ducting is less than efficient and could possibly cause additional strain on roofing.

As noted in the costs report provided by Solace Enterprises in **Appendix B**, the existing ductwork has been converted and has been exposed to weather and is near failure.

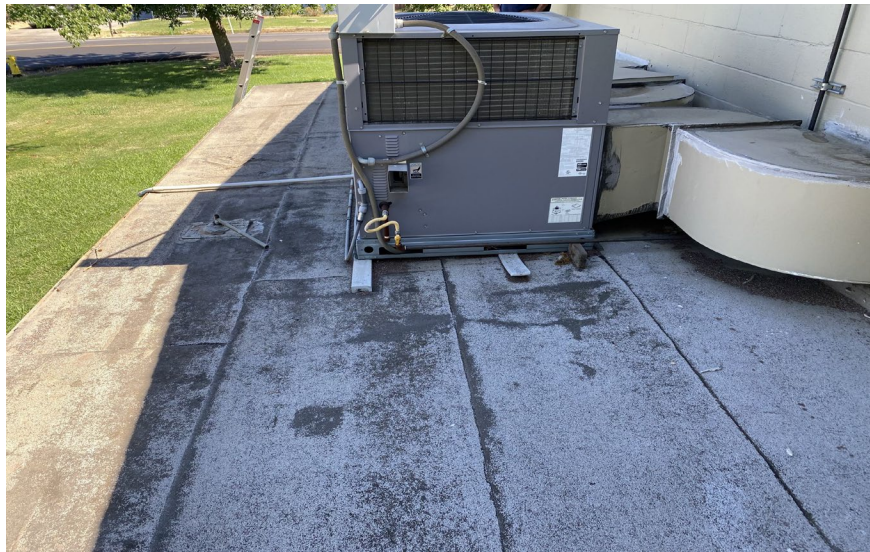
The majority of the roofing was recently done and looks to be in excellent condition. However, when this project was taken on, the back 350 square foot overhang was not included in the project and has a roof that at this time is nearly not safe to walk on. As you can see in the photo below, the HVAC unit was even placed on top of the roofing membrane very little blocking. This roofing was placed on top of the existing wood decking, so to replace the HVAC unit would need to be lifted, the wood decking torn out and replaced, as well as re-setting the HVAC unit.

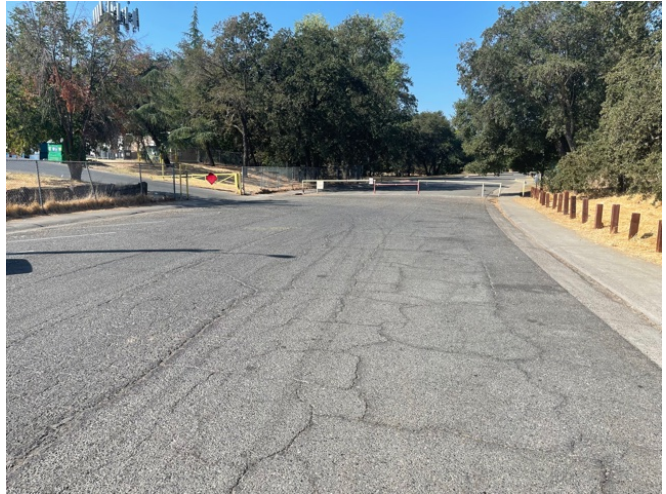
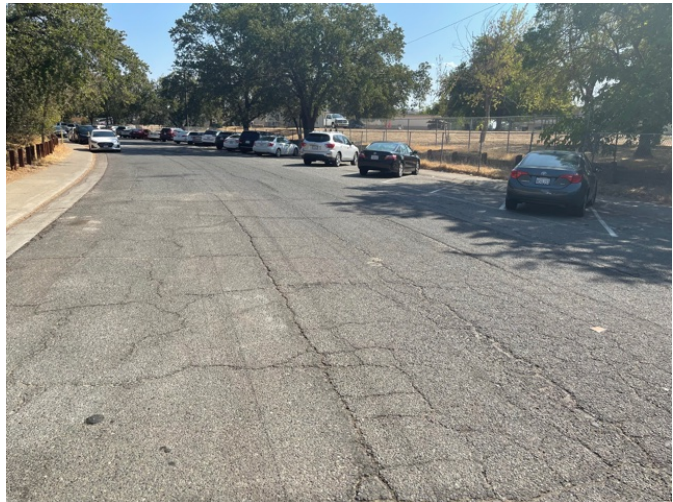
These areas are also presenting with severe cracking, to which filling, and slurry coating will not hold. The general recommendation for these paved areas is to grind down the top 3" (approximately) and apply a new topcoat of asphalt. However, it has been noted that in the past during repairs the current asphalt was not installed with base. With that information, it is recommended that an engineering firm be engaged to perform a coring to fully determine the needs of the site. In order to budget appropriately, a full tear out and replace is quoted in site costs
